Report No. 79-2

Demonstration of
MARSH TURBO THRUSH
to Deliver Pesticides
to Coniferous Forests

DECEMBER 1978

Methods Application Group
Forest Insect and Disease Management
Forest Service, USDA
Davis, California

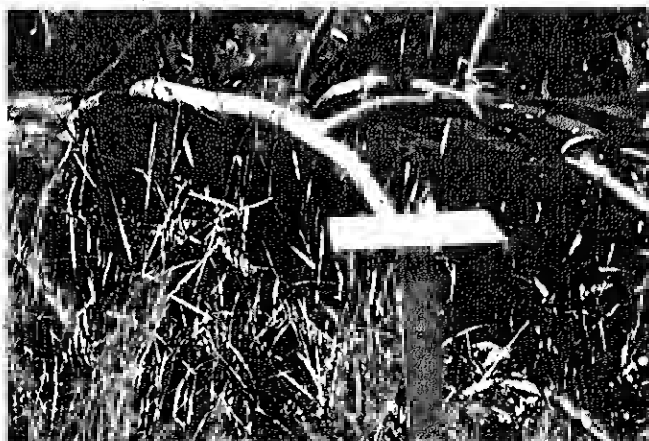
Figure 13. Kromekote card in holder at stake position A-1. A is sampling A and 1 is the first sampler in line A. Turbo Thrush test, Idaho 1978.

Four spray deposit card lines were established in each block (Fig. 6). Lines were 933 feet apart and perpendicular to the expected flight path. A sample site (Fig. 13) was selected every 75 feet along each card line unless the point fell on or within one foot of a tree trunk,

in which case the site was moved a foot or two in any direction. Clinometers were used for slope compensation so the distance between sample sites was a horizontal distance, not a slope distance. At each sample site a 1 x 2-inch wooden stake, three feet high, was used to hold a deposit card sampler. The card line number and sample number were marked on each stake. Standard Kromekote spray deposit cards were positioned just before spray application (Fig. 13).
